TECHNICAL BULLETIN

3-TONNE 'TITAN' BRAND CHAIN BLOCK

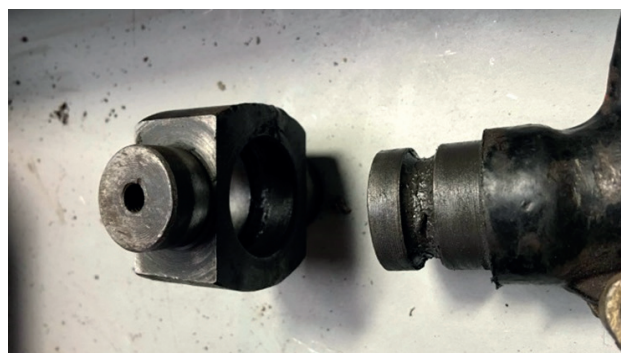
On closer inspection it was noted that the plug, that holds the ball bearings in the crosshead that anchors the hook and allow the hook to swivel, was missing.

This in turn had allowed the bearing balls to escape allowing the hook to become detached.

Close inspection showed no significant wear or fatigue on any component.

All equipment with similar systems for securing the load hook to the block should be closely examined prior to ongoing further use
