Arm Trapped in Felling Head during Repair

A machine operator's arm become trapped between the felling head's superstructure and the ram that controls the grapple fines. The accident occurred during a repair task. The injured worker was airlifted to hospital where he received treatment for compression injuries.

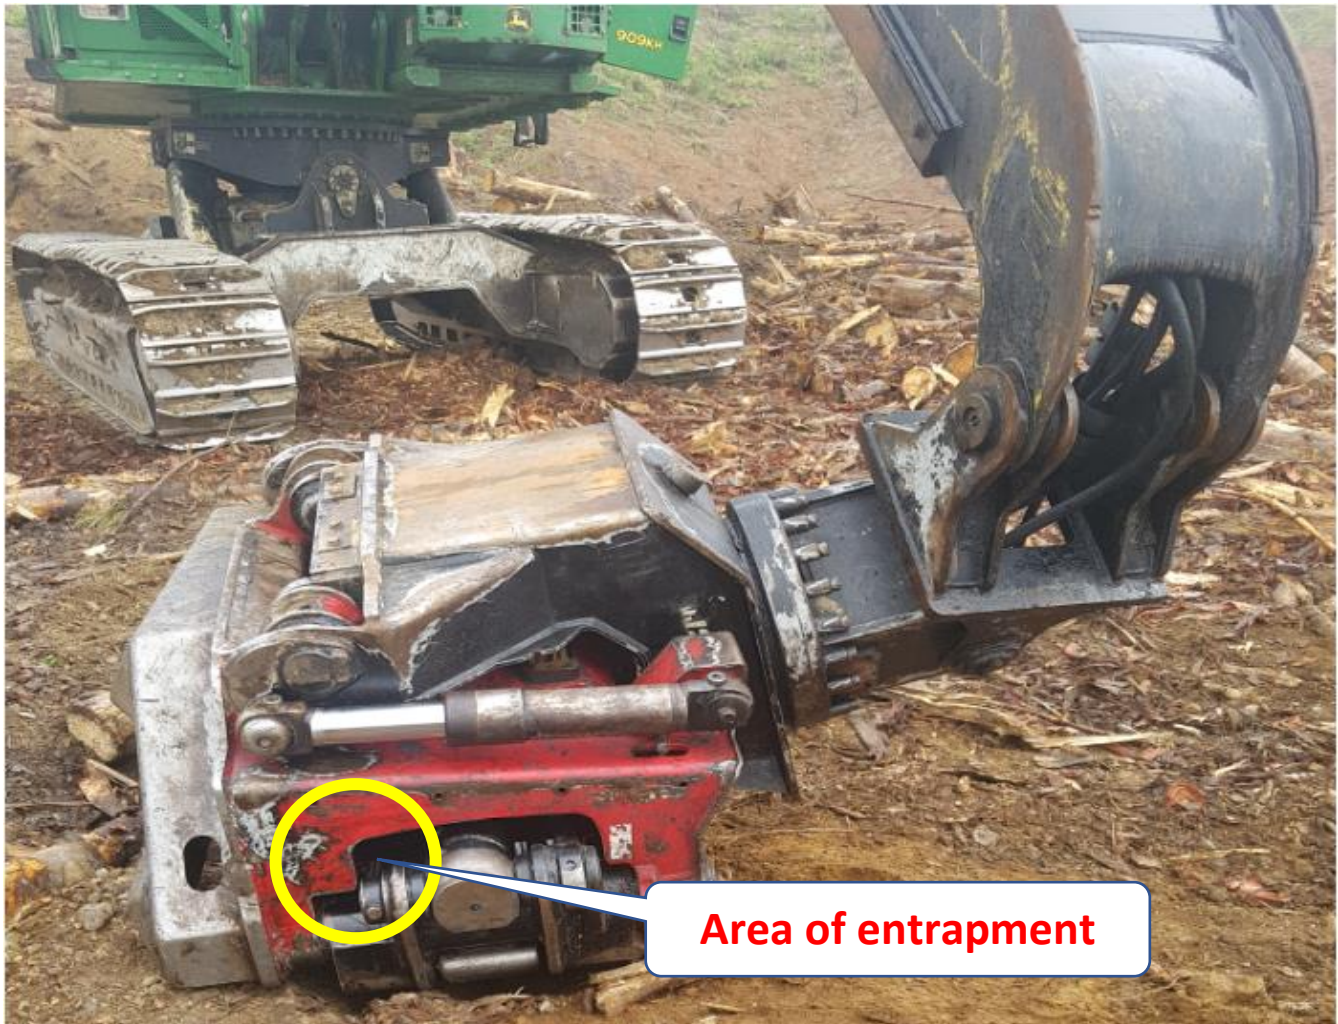
A small pin hole leak had been identified on a Waratah FL95 felling head ram responsible for the opening and closing the grapple. The machine was parked up for repair and a service provider called in to carry out the welding needed.

To repair (weld) the crack, hydraulic oil had to be removed from the ram. This required the hose connection to the ram valve bank to be released. The operator put his arm through a narrow gap at the grapple hinge point to loosen the connection. This released some but not all of the pressure and as the welding proceeded the ram began to weep oil. The repair was stopped and the operator put his arm back through the gap and released the residual pressure by undoing the connection fully. This caused the grapple to open (creep) and trap his arm between the super structure and grapple ram. There may have also been some movement in the boom that contributed to the head's movement.

Compression on his arm involved approximately 25mm of closure movement and it took approximately 20 minutes to free him.

- The crew's Job Safety Analysis (JSA) for R&M wasn't followed. If it had, a different process would have been used (ie: Position the felling head in a safe and stable position before removing the valve bank cover and releasing any stored pressure. Then move the felling head to a suitable work position for the welding) – in other words the machine had been positioned to best suit the weld, not the hose removal

- The recommended isolation and tag out procedure was not followed (the harvester was isolated but not tagged out - the tag was in the harvester).
- The most experienced member of the crew was working on another machine at the time of the incident. He had been involved in the earlier induction of the service agent onto the site but not directly overseeing the repair, as he normally would.

- Despite good production, prior breakdowns may have put perceived pressure on operator
- During the hose removal the machine's boom may have crept forward. This may have contributed to the rolling of the felling head and movement of the grapple arm.

- Always ensure those carrying out the task are familiar with and follow established safe practices for the repair or maintenance task at hand (includes crew procedures and the manufacturer's maintenance manuals).
- If there is insufficient guidance, ensure a risk assessment is carried out.
- High risk work must be adequately supervised, where skill or experience is still being developed.
- Where two or more people are undertaking an R&M task, agree on who is in charge.
- Ensure the boom is stable.
