April 2018

## MINING AND QUARRY OPERATIONS

# Over-inflation of jumbo tyre resulting in explosion

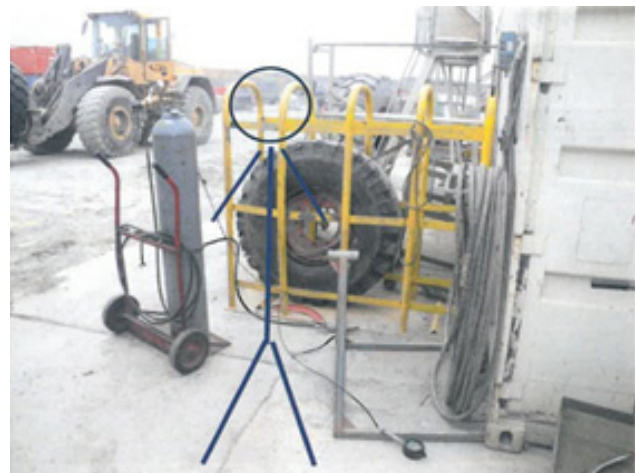
The tyre cage was not certified for safe use by an engineer.

**FIGURE 1:** The nitrogen cylinder cage and where the worker was standing

Certified tyre cages need to be used to ensure the design and fabrication of the cage can withstand forces generated from tyre explosions and prevent fragments being ejected from the cage.

Installation of blast walls is required to protect the person inflating tyre.

Long air lines should also be used to remove people from the proximity of an explosion.

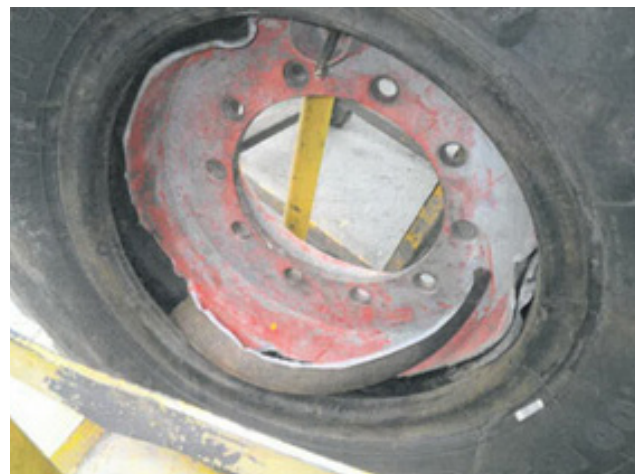
A trade assistant at a large underground metalliferous mine was injured when a Jumbo tyre was over-inflated to the point it exploded.

The over-inflation occurred because an electronic gauge used to measure the inflation pressure was wrongly set on Bar and not psi.

**FIGURE 2:** Rim damage after explosion

Gauges used for inflating tyres must be accurate and have an appropriate operating pressure range so inflation pressure can be read accurately, and not be interchangeable with other systems.

Inflation systems must have built-in pressure release valves so in the event of system failure there is a pressure release control to prevent an explosion.
