MINING AND TUNNELLING OPERATIONS

Raising or lowering of workers using a crane

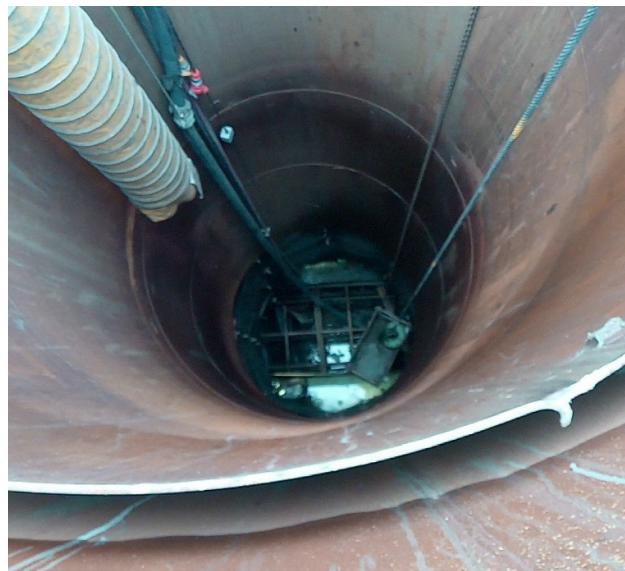
A 30 tonne telescopic boom crawler crane was being used to lift workers, materials, and equipment in and out of a 15 m deep x 3 m diameter shaft. Two workers had been lowered to the shaft bottom in a man cage. To allow them to continue working, the man cage was hoisted approximately four metres up from the shaft bottom and moved to the side of the wall.

FIGURE 1: Incident Two: View of man cage looking down shaft

Once the man cage was clear of the shaft bottom, the crane operator applied the winch brake, turned the motor off, and exited the crane cab. The operator used the standby time to tidy around the crane and help workers at the shaft top. Approximately 1.5 hours after the crane had been turned off, the workers at the top of the shaft heard and saw the crane hoist wire running down and the man cage hit the bottom of the shaft, tipping over on impact. The hook block also hit the shaft bottom. There were no injuries and the two crew members in the shaft were rescued.

Operators should avoid using cranes with a freefall device installed when used to raise and lower workers. Raising or lowering workers using a crane is a critical risk that requires effective controls and effectiveness monitoring. Critical risk controls must be understood by all workers and applied without exception to ensure everybody's safety.
